**DEPARTMENT OF TRANSPORTATION****DIVISION OF ENGINEERING SERVICES**

Contract #: 04-0120F4Cty: SF/ALA Rte: 80 PM: 13.2/13.9File #: 69.28**WELDING INSPECTION REPORT****Resident Engineer:**Pursell, Gary**Address:** 333 Burma Road**City:** Oakland, CA 94607**Report No:** WIR-000258**Date Inspected:** 07-Jul-2007**Project Name:** SAS Superstructure**OSM Arrival Time:** 800**Prime Contractor:** American Bridge/Fluor Enterprises, a JV**OSM Departure Time:** 1730**Contractor:** Zhenhua Port Machinery Company, Ltd (ZPMC), Changxing Island **Location:** Shanghai, China**CWI Name:** Lu Jian Hua**CWI Present:** Yes No**Inspected CWI report:** Yes No N/A**Rod Oven in Use:** Yes No N/A**Electrode to specification:** Yes No N/A**Weld Procedures Followed:** Yes No N/A**Qualified Welders:** Yes No N/A**Verified Joint Fit-up:** Yes No N/A**Approved Drawings:** Yes No N/A**Approved WPS:** Yes No N/A**Delayed / Cancelled:** Yes No N/A**Bridge No:** 34-0006**Component:** Thermal Cutting of Steel Plates**Summary of Items Observed:**

**Tower 77 Meter Mock-Up Thermal Cutting of Steel Plate**

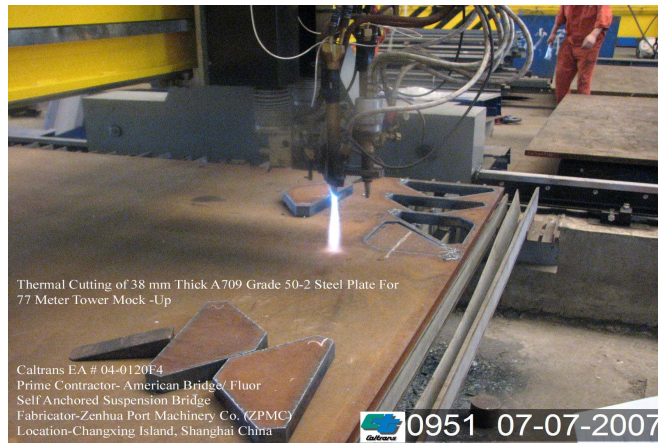
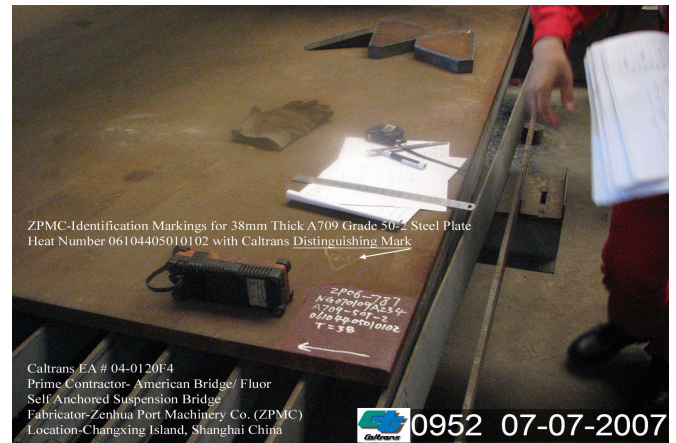
Item	Description	WBS	Dwg No.	Status
1	38 mm Thick A709 Grade 50-2 Steel Plate	N/A	N/A	N/A
The Caltrans QA Inspector observed the plate identification markings for this plate and identified a heat number of 06104405010102. The Caltrans QA Inspector also observed a Caltrans QA OSM distinguishing mark that identifies that this steel plate has been previously observed and verified by Caltrans OSM Inspector's on-site. The Caltrans QA Inspector observed that ZPMC is utilizing computer numeric controlled (CNC) equipment for the thermal cutting. The Caltrans QA Inspector was informed after some exchange of interpretation by several ZPMC representatives that the thermal cutting gases being used consist of oxygen and propane. Upon verification of the steel plate heat number, ZPMC proceeded with the thermal cutting of four gusset plates. At the completion of the thermal cutting the Caltrans

QA Inspector observed that the thermally cut steel plates have smooth and regular surfaces that are notch free and that appear to comply with AWS D1.5 (2002) section 3.2.3. Included below are digital pictures of this observation.

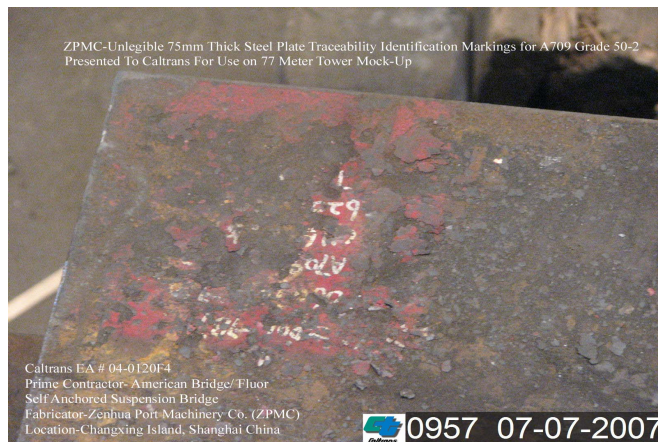
2 75 mm Thick A 709 Grade 50-2 Steel Plate N/A N/A N/A

The Caltrans QA Inspector observed that the presented 75 millimeter thick steel plate contains a thick layer of rust and heavy mill scale. The Caltrans QA Inspector brought it to the attention of ZPMC and ABF representative Mr. Jeff Evans that the traceability identification markings for the steel plate are unlegible. There was a significant effort by ZPMC representatives and Mr. Jeff Evans to locate the steel mill steel stenciled identification heat number. This steel stenciled heat number was located, however was extremely difficult to read. Mr. Jeff Evans and ZPMC utilized manually applied wire brushing and also the application of water and manual scrubbing using rags to enhance the steel stenciled heat number. An artificial powered light was also utilized to identify the steel heat number. After a period of time, the Caltrans QA Inspector observed with the ABF and ZPMC representatives a heat number that was barely legible. This heat number was recorded as 6206259N. The Caltrans QA Inspector was not present for the thermal cutting of this plate that occurred after the QA Inspector departed. Included below is a digital picture of this observation.

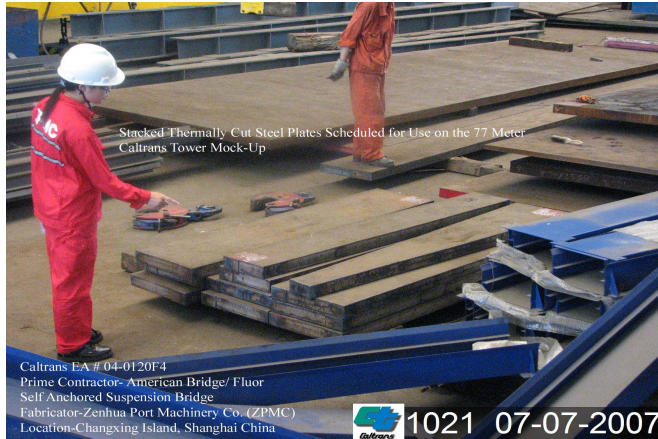
Tower 77 Meter Mock-Up Thermally Cut Steel Plate

The Caltrans QA Inspector observed that ZPMC has started to stack several thermally cut steel plates of various sizes in an area adjacent to the CNC thermal cutting device. Included below is a digital picture of this observation.

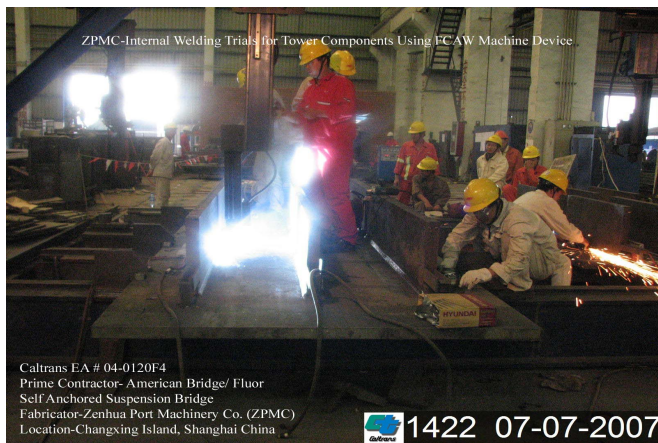
| | ZPMC-Internal Practice Welding of Tower Mock-Up Sub-Assemblies | | |

The Caltrans QA Inspector observed that there are numerous ZPMC welders at various locations of the tower mock-up fabrication area that are welding on various tower mock-up sub-assemblies that ZPMC is utilizing as informational practice purposes. Included below is a digital picture of ZPMC welders that are using a flux cored arc welding machine to weld a double bevel groove weld in a tee joint configuration.

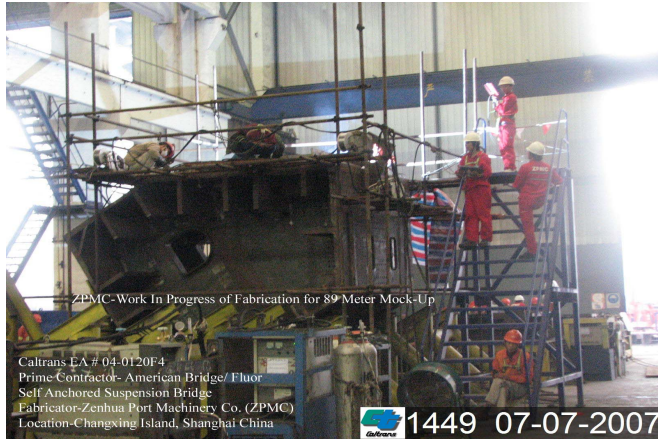
| | ABF-89 Meter Mock-Up | | | |

The Caltrans QA Inspector periodically observed that there are approximately ten (10) to fifteen (15) ZPMC workers that are grinding and welding and also monitoring work on the upper section of a skin plate. These ZPMC workers included welders and quality control personnel. Included below is a digital picture of this observation.

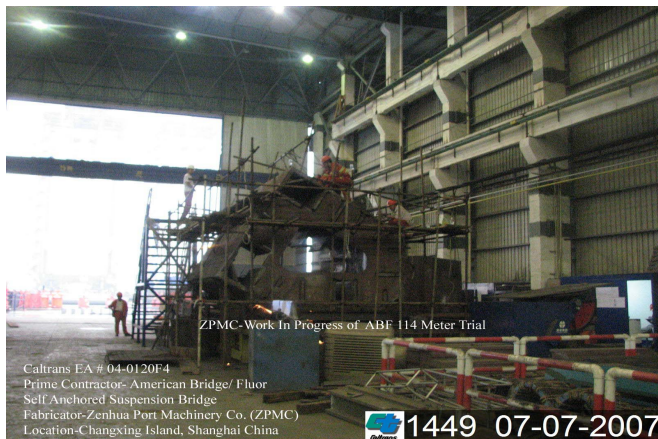
| | ABF-114 Meter Mock-Up | | | |

The Caltrans QA Inspector periodically observed that there are approximately five to ten (10) ZPMC workers that are performing dimensional measurements and also are grinding various surfaces of the stiffener bolt connection splices. Included below is a digital picture of this observation.

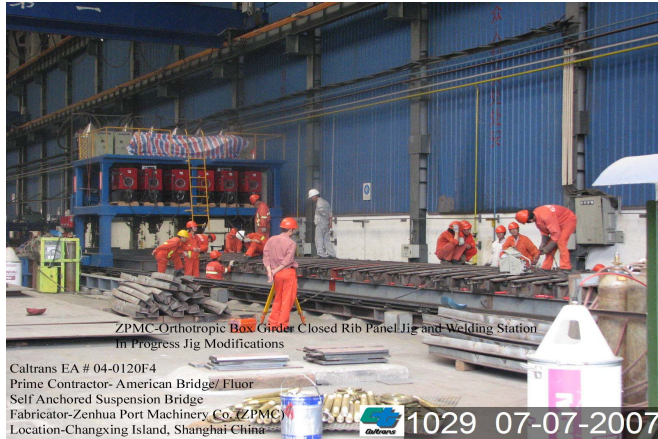
| | ZPMC-OBG-Panel Welding and Fit-Up Jig Station | | | |

The Caltrans QA Inspector observed that there are approximately 15-20 workers that are performing various functions to the orthotropic box girder panel fit-up jig. The Caltrans QA Inspector observed that ZPMC is modifying the transverse cambering supports for the fit-up jig. Some of these transverse cambering supports are being removed and replaced. Included below is a digital picture of this observation

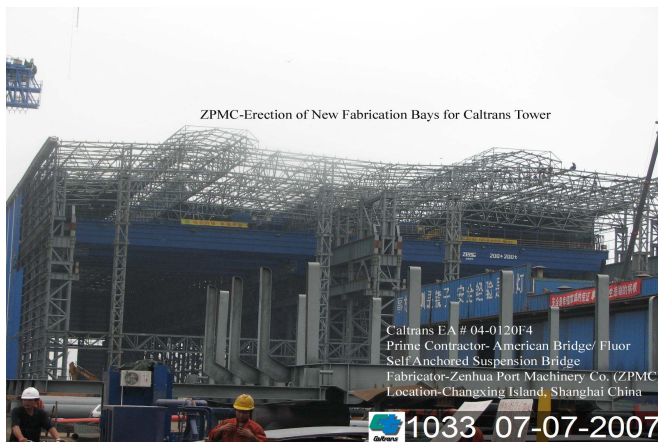
- 8 ZPMC-New Tower Fabrication Area Bays N/A N/A N/A  
ZPMC-New Tower Fabrication Area Bays

The Caltrans QA Inspector observed that ZPMC has positioned cranes within the new tower fabrication bays that are being fabricated for the construction of the tower sub-assemblies. Included below is a digital picture of this observation.
